Most Innovative Design Award

Pikes Peak Summit Visitor Center

Colorado Springs, CO

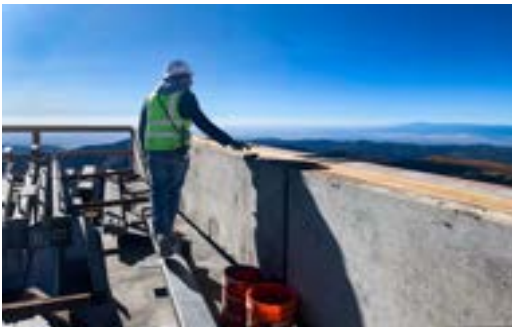
Below: No through-roof penetrations were allowed on the standing seam roof. At the perimeter of the roof, a custom gutter and coping is made of steel plate to resist the harsh weather conditions and to be electrically continuous with the air terminals.

Exposed elements of the structure had to be hardened to withstand conditions. For example, exposed conductor cables were avoided wherever practical, air terminals bases were provided with extra-strong attachment to structure, and through-structure penetrations were minimized. Permanent metal fabrications – including railings and roof gutters made from steel plate – were used as strike termination devices and in lieu of conductor cables.

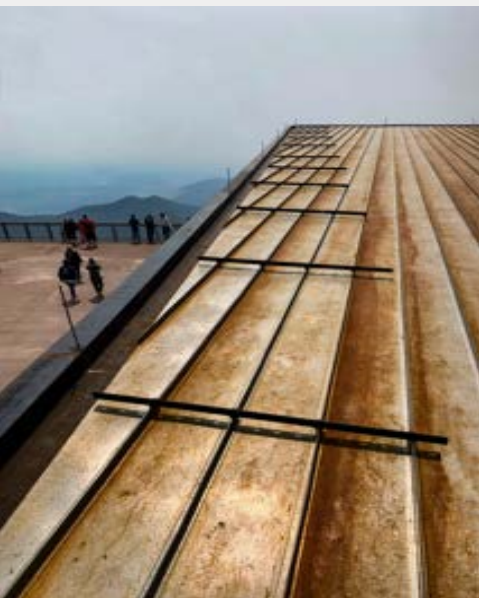
Above: At rooftop terraces, conductor cables were covered with concrete topping slabs. Vertical threaded rods were attached to metal railings that serve as strike termination devices.

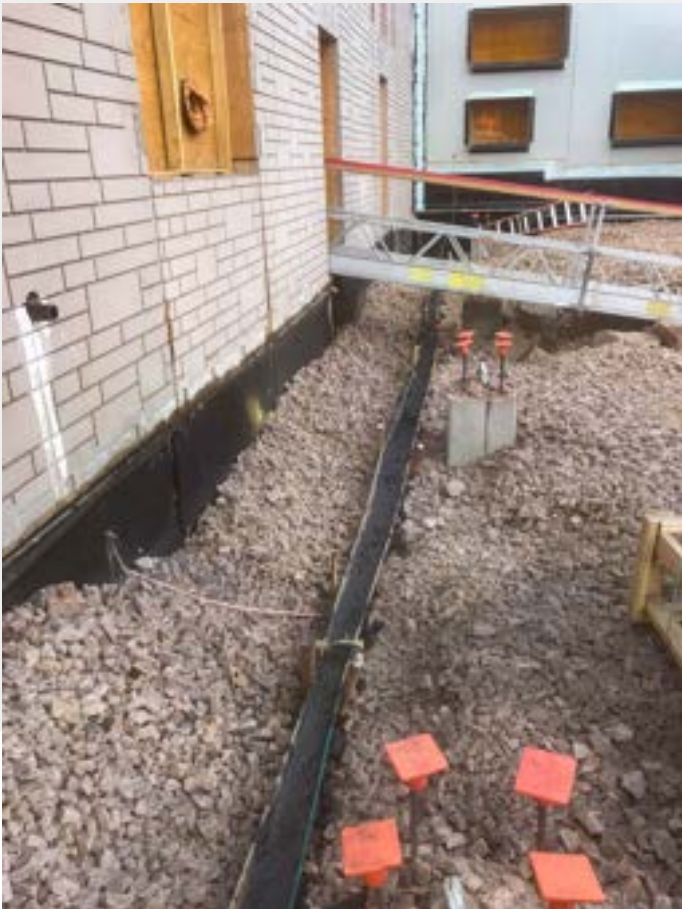
The ground loop cable around the High Altitude Research Laboratory was embedded in ground enhancing material due to the low conductivity of the rocky soil. (Below)

The Summit House is built on granite with a very low soil conductivity. This required aggressive measures to achieve satisfactory grounding. Techniques employed included ground loops, ground enhancing material, and welded connections.

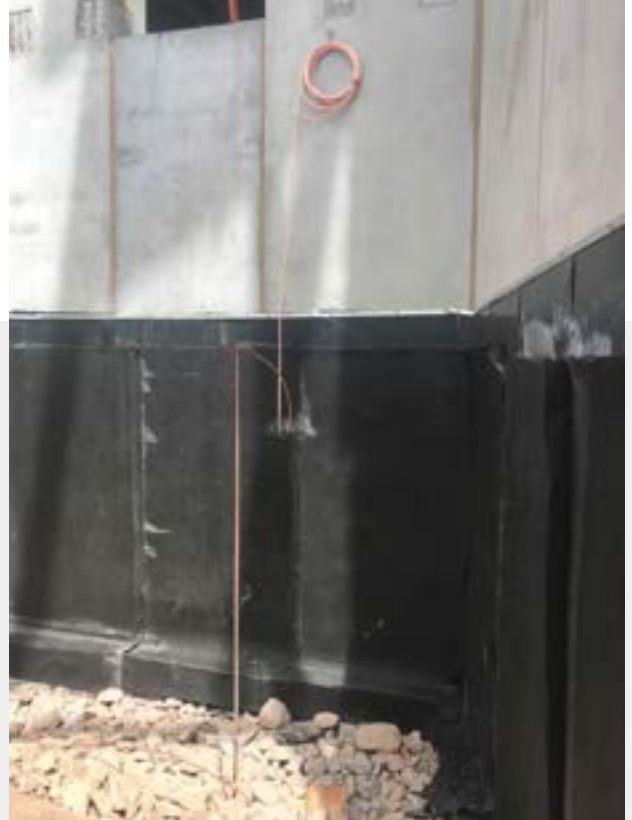
The Summit House has both a ground loop and ground rods to overcome the low conductivity of the rocky soil. Because ground rods could not be driven in the rocky soil, they were installed at the base of excavations, then covered with backfill. The conductor cable hanging on the wall was concealed when wall cladding was installed. (Above)

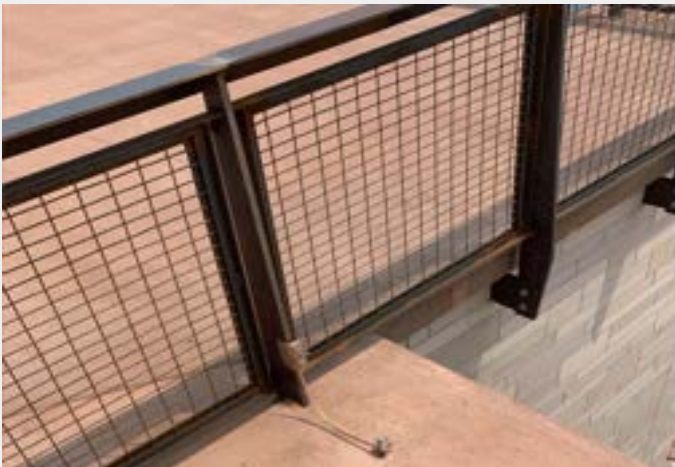
Below Left: Railings, made of weathering steel, are electrically continuous with the lightning protection system and used as strike termination devices.

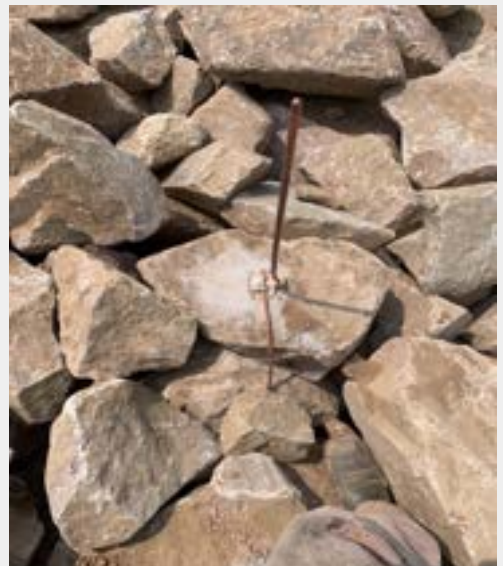
Above Right: Portions of the rooftop terrace are covered with stone to look like the natural mountaintop. The air terminals installed on the rock is made of copper to better match the rock.

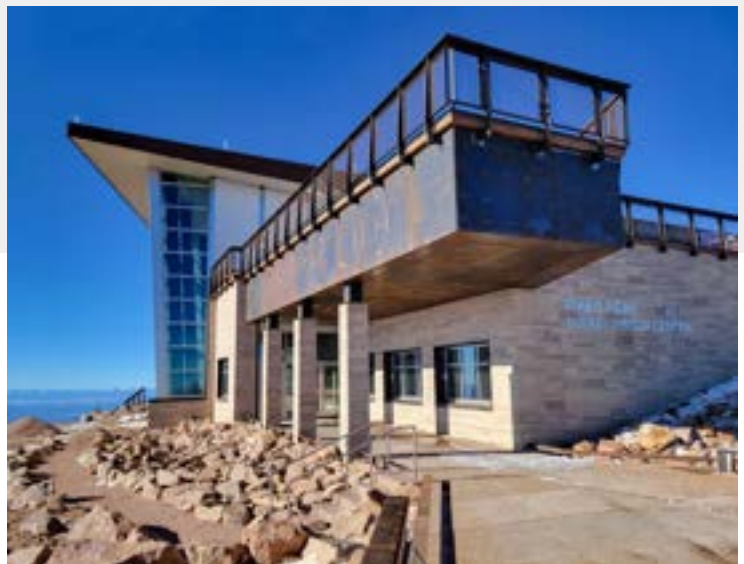
Right: The eastern face of the building rises out of the mountain's side to offer commanding views into the distance. The steel railing is used as a strike termination device. The slender air terminals reflect the light of the sky.
